The Aaron Parker House

Rockdale County, Georgia
Structural Assessment Report

Aaron Parker House Structural Assessment Report

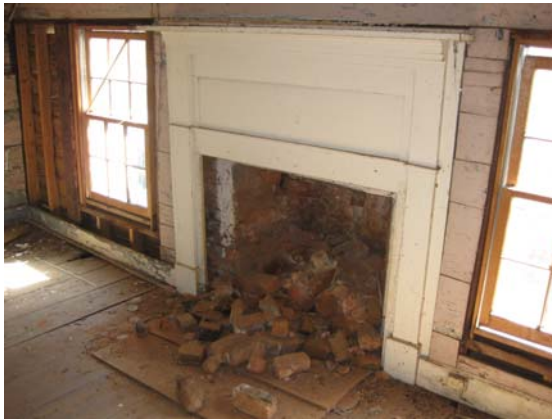
Second floor, note collapse of firebox

Since the DNR acquiring the property park staff noted that partial collapse of brick and mortar from chimneys and fireplaces into rooms of the house had occurred (see image, left) and noted possible settlement of the chimneys, evidenced by separation of the chimneys from the house and out of plumb conditions. Staff had also expressed concern over potential damage if one of the chimneys were to collapse, safety of the house based on its structural condition, and the potential for further deterioration of the house due to the large openings between the house and chimneys that allow water and pest access.

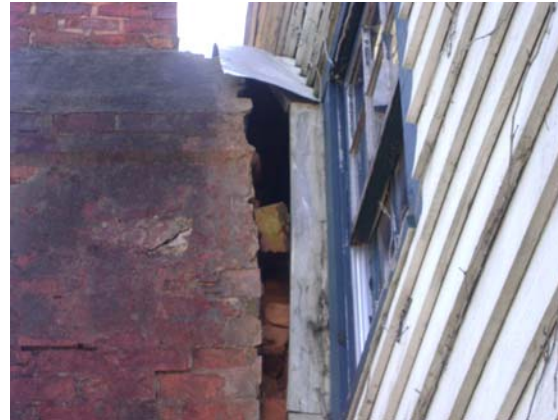
Chimney at exterior, note opening at wall exposing wall cavity

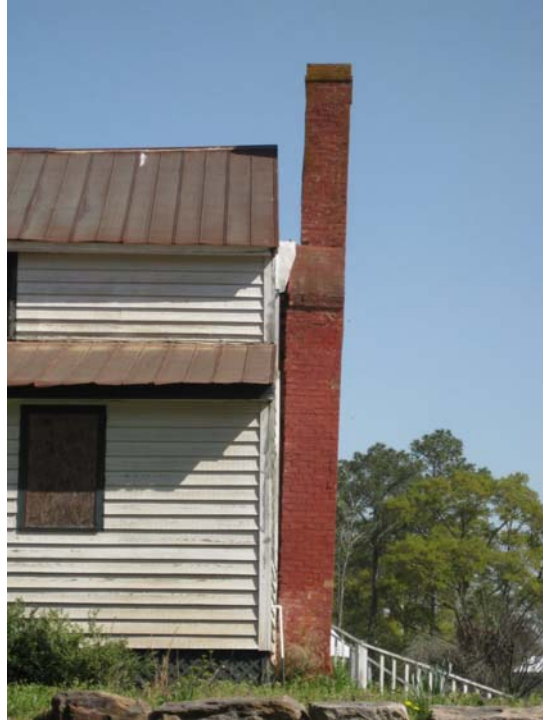
6. Partial South Elevation, Note opening at wall and out-of-plumb chimney condition

There are two brick chimneys, one on each end of the house, that are out of plumb, approximately three degrees for the main portion. The upper section is slightly more out of plumb. The foundations are not known, however, it is likely that the chimneys are resting directly on ground. A concrete masonry base has been added at the ground, but it appears to be ineffective. The brick inside the chimneys have fallen in several places, especially at the second floor fireplaces.

The two brick chimneys are in fair conditions, but both are leaning out of plumb. The chimneys appear to be stable at the present time. However, due to deterioration of brick inside the chimneys and the fireplaces a potential danger to staff and the house exists.

- The front porch should be covered with ½-inch plywood to provide short-term stability. This does not provide access for the public. An alternate to this action would be to completely rebuild the porch.
- Based on observations of existing conditions, difficulty of repair of interior of the brick chimneys, and possibility of collapse, the chimneys should be dismantled. The bricks should be identified, and stored on site for future reconstruction. A new footing should be provided at that time.

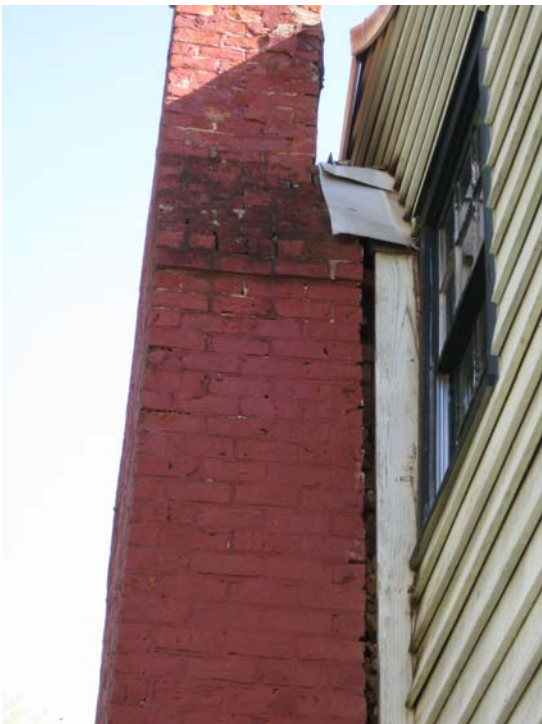
7. Chimney @ West Elevation

Note brick and mortar that has collapsed into rooms at all fireplace locations (photograph nos. 7, 8, 9, and 10)

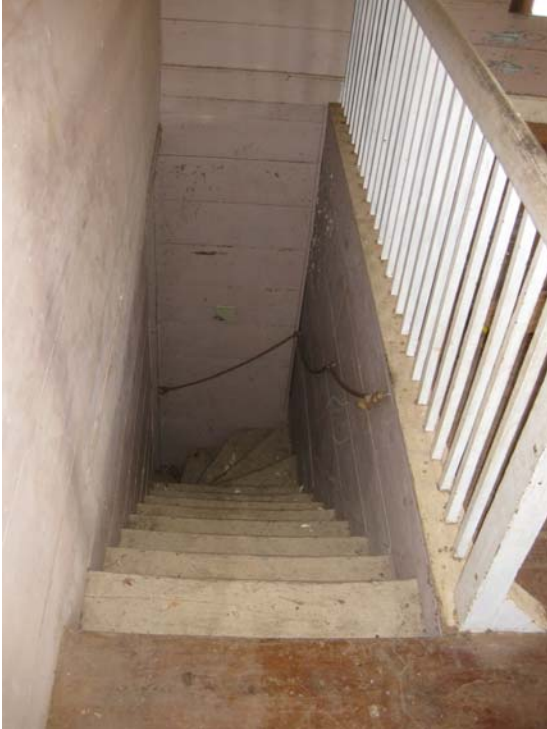
15. Existing Staircase and Railing

The interior stair case is wood construction, and appears to be in good condition. However, the dimensions of the stair do not meet current code requirements.

The stairs are structurally satisfactory for residential or office loading, but the dimensions do not meet current code requirements.
